# Manhole Inspection Summary

Manhole # S37C\_\_009MH

**Inspection** ☐ Is Incomplete Rating: **3) Fair**

**Location** Address: **808 groome al**

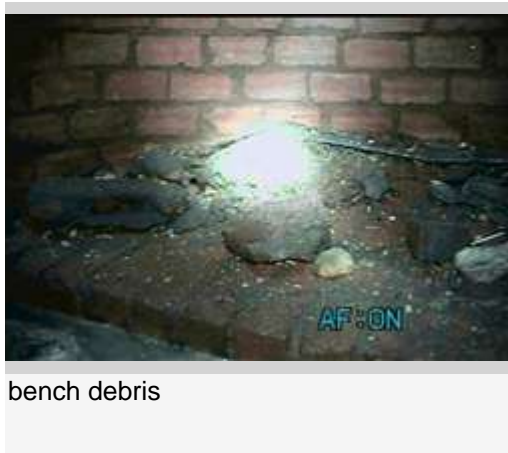
Defect 4

Condition: ☐ Sound ☐ Cracked ☐ Root Intrusion ☐ Deteriorated ☐ Leaks ☒ **Debris**

bench debris

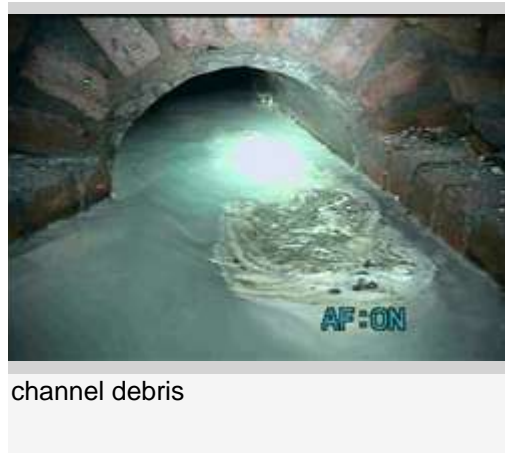
Defect 3

Condition: ☐ Sound ☐ Cracked ☐ Root Intrusion ☐ Deteriorated ☐ Leaks ☒ **Debris**

channel debris

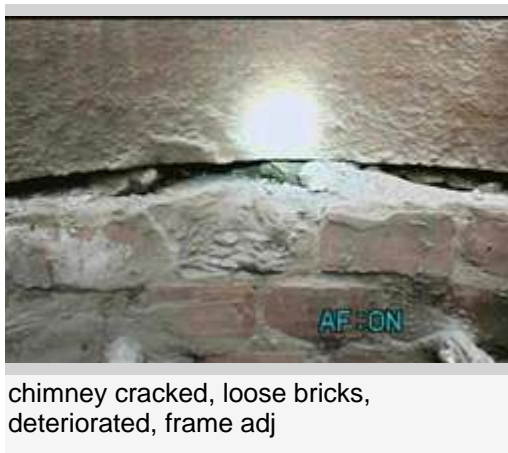
Defect 2

Condition: ☐ Sound ☒ **Cracked** ☐ Root Intrusion ☒ **Loose Brick** ☒ **Deteriorated**

chimney cracked, loose bricks,  
deteriorated, frame adj

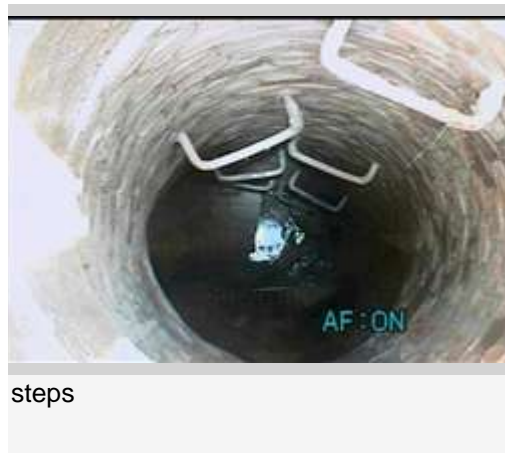
Defect 1

Count: **8** Missing: **0** ☒ **Corroded**

steps

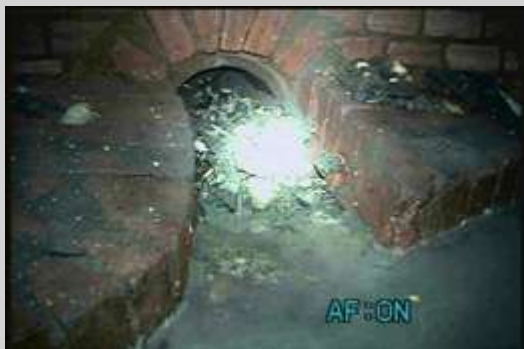
4 O'Clock Inflow

Deposits: ☐ None ☐ Mud ☐ Sludge ☒ **Debris** ☐ Grease

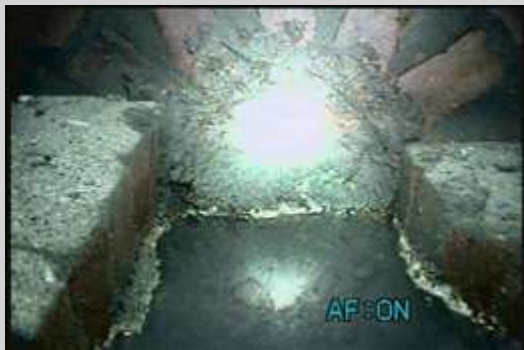
9 O'Clock Inflow

Deposits: ☐ None ☐ Mud ☐ Sludge ☒ **Debris** ☐ Grease
